RESEARCH MEMORANDUM

FLYING QUALITIES OF A HIGH-PERFORMANCE

PERSONAL-OWNER AIRPLANE

By James J. Adams and James B. Whitten

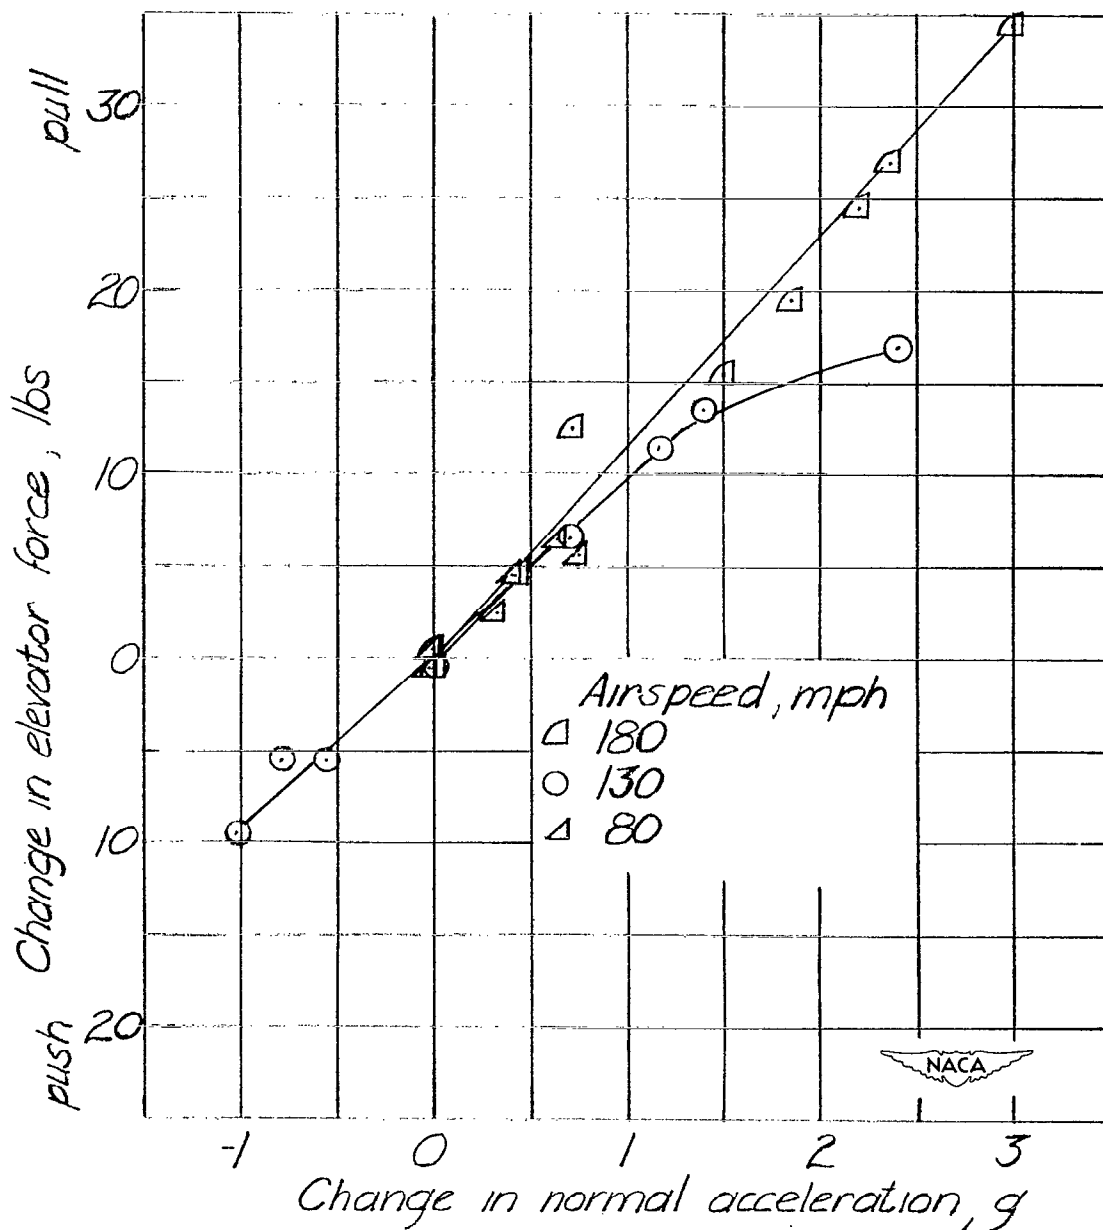
Figure 11.- Variation of elevator force with normal acceleration in steady pull-up and push-down maneuvers for three different airspeeds in the power-on clean condition at a center-of-gravity position of 29.3 percent mean aerodynamic chord for the Beech B-35 Bonanza airplane.

Longitudinal control.- The longitudinal control characteristics were measured by performing steady pull-ups, push-downs, and turns at various speeds and center-of-gravity locations and measuring the elevator control force. Plots of the elevator control force against g are shown in figures 10 and 11. From figure 10 it can be seen that the variation of elevator force with g is linear, falling off only when the airplane approaches the stall. The variation of force per g with center-of-gravity position obtained from figure 10 was extrapolated to give the force per g values at the most forward and rearward allowable center-of-gravity positions. The values of 21 pounds per g to 10 pounds per g determined in this manner were considered to be in a satisfactory range.

Figure 11 shows the variation in elevator force with g throughout the speed range. Changing the speed had very little effect on the force per g variation.

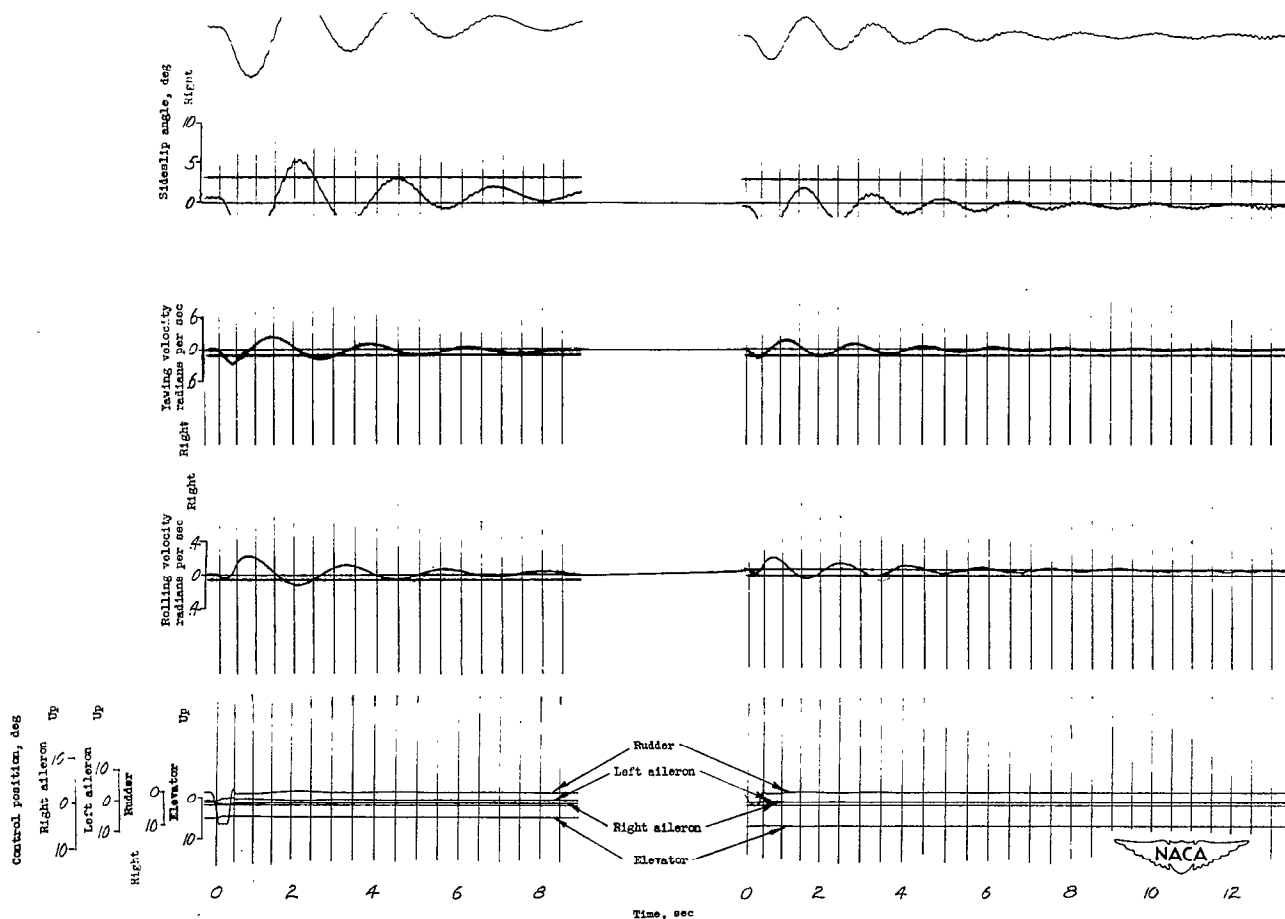
(a) 130 miles per hour.

(b) 160 miles per hour.

Figure 12.- Time histories of the control free oscillations following a rudder kick in the Beech B-35 Bonanza airplane. Airplane in the power-on, clean condition. Center of gravity located at 26.1 percent mean aerodynamic chord.

Dynamic lateral stability.- The dynamic lateral stability was tested by trimming the airplane at 160 and 130 miles per hour in the clean condition and abruptly moving the rudder and then releasing all of the controls. Time histories of the resulting oscillations are presented in figure 12. The period of these oscillations was approximately 2.5 seconds at 130 miles per hour and 1.8 seconds at 160 miles per hour, and approximately $1\frac{1}{2}$ cycles at 130 miles per hour and 1 cycle at 160 miles per hour are required to damp to one-half amplitude. An analysis of the oscillations showed that there was a reduction in damping as the amplitude of the oscillations became smaller. In the previous

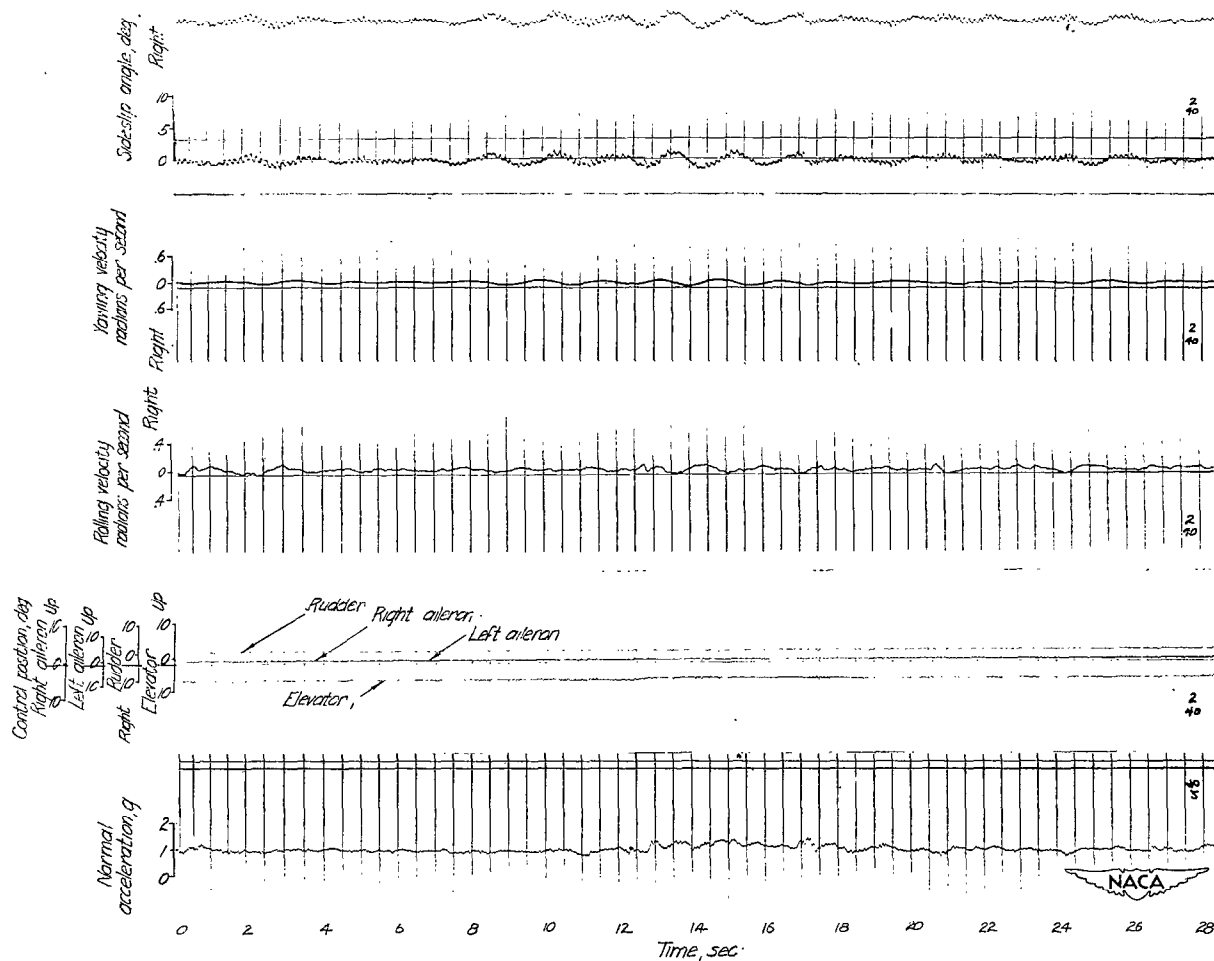
Figure 13.- Example of the lateral oscillations encountered with the Beech B-35 Bonanza airplane in rough air. Airspeed = 140 miles per hour.

As a result of the low damping of the lateral oscillations, the Bonanza was subject to continuous oscillations in rough air, an example of which is shown in figure 13. The pilots stated that it was impossible to stop these rough air excited oscillations. This characteristic made instrument flying in rough air without a directional gyro or a artificial horizon unduly tiring because the rate of turn indicator was being continuously excited and required almost constant pilot attention.

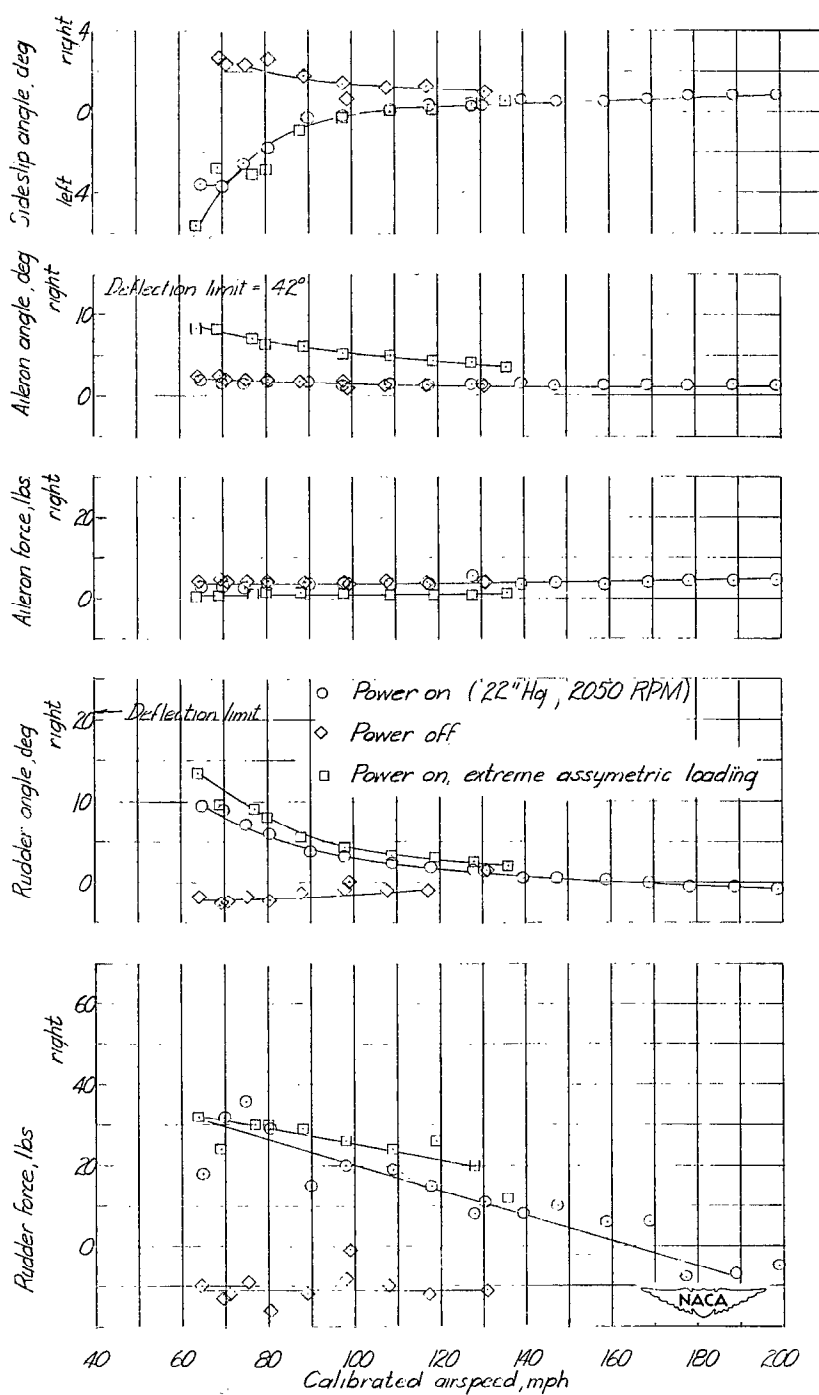
(a) Clean condition.

Figure 14.- Variation of rudder and aileron position and force with airspeed for the Beech B-35 Bonanza airplane.

Rudder and aileron trim characteristics.- The rudder position and force, and the aileron position and force and the sideslip angle were measured throughout the speed range and are shown in figure 14. It can be noted from figure 14 that the rudder position and force for the power-on, clean condition and landing condition become high at the lower speeds, the rudder force amounting to 65 pounds in the power-on, landing condition. Since there is no rudder trim device, there is no way to reduce this force.

In order to determine if there was sufficient control for the most critical condition for lateral trim, the airplane was flown with the most asymmetrical loading possible. The left gas tank was filled, and the right tank was left empty; also the left seat was occupied and the right seat was vacant. The rudder position and force and the aileron position and force for this condition are also shown in figure 14. There was sufficient control to trim the airplane, but again the rudder trim force was excessive.

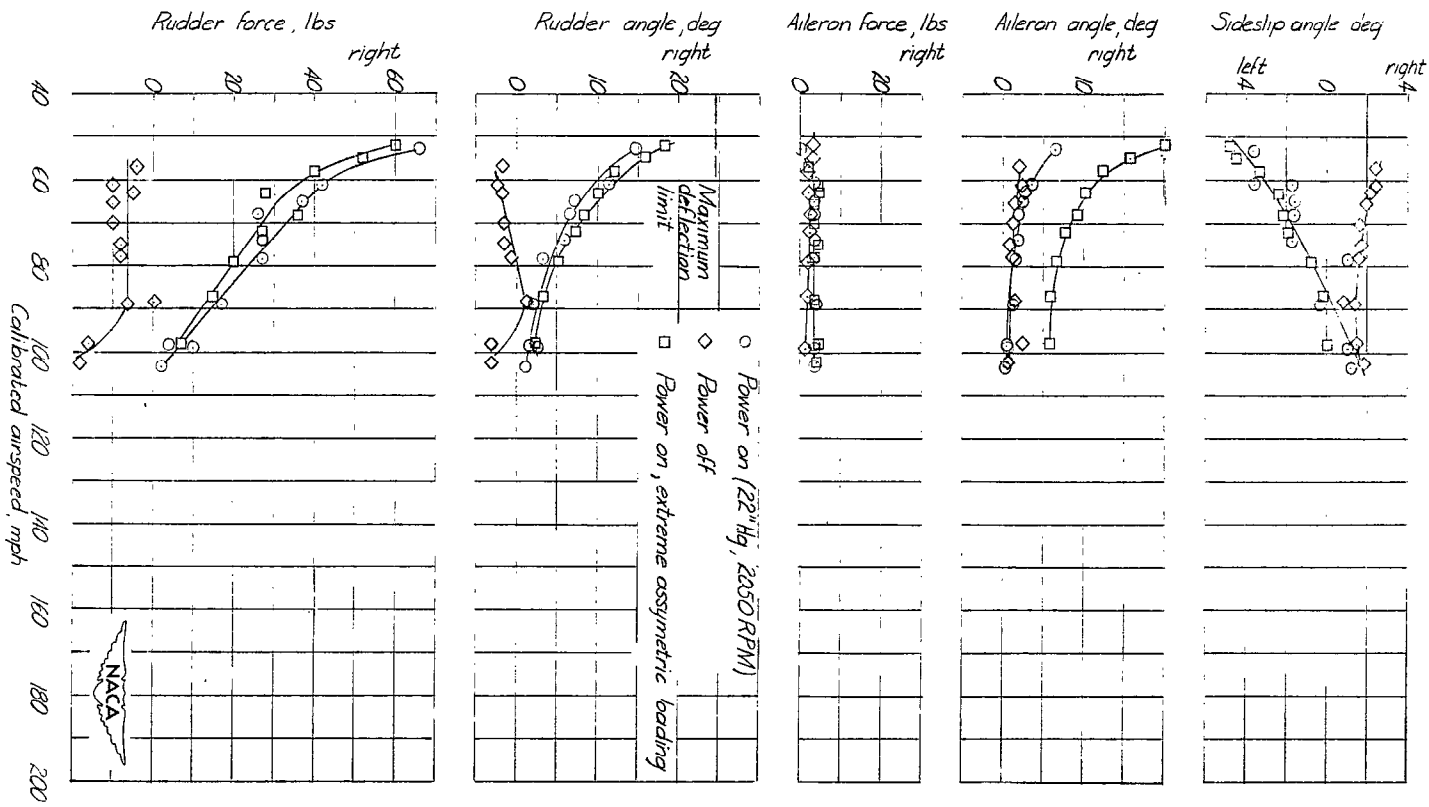
(b) Flaps and gear down.

Figure 14.- Concluded.

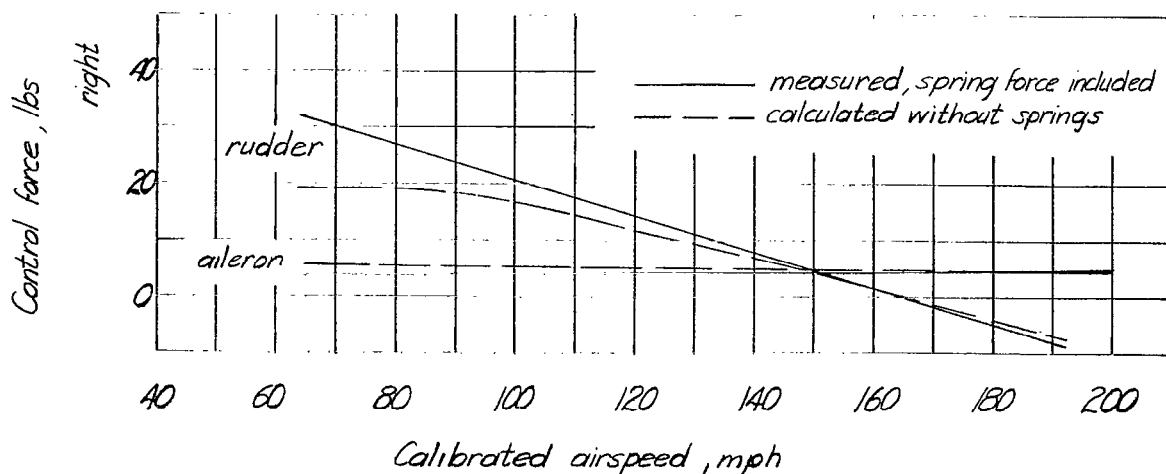
(a) Power on, clean condition.

Figure 15.- The effect of the aileron-rudder coupling springs on the rudder and aileron force variation with airspeed for the Beech B-35 Bonanza airplane.

The effect on the lateral and directional trim characteristics of the rudder-aileron coordinating spring is shown in figure 15. The curves represent the rudder and aileron forces as measured, which includes the spring force, and the rudder and aileron forces without the spring, which were obtained by subtracting the calculated spring force from the measured force. The comparison shows that less rudder force, but slightly more aileron force is required for trim at low speeds with the spring removed.

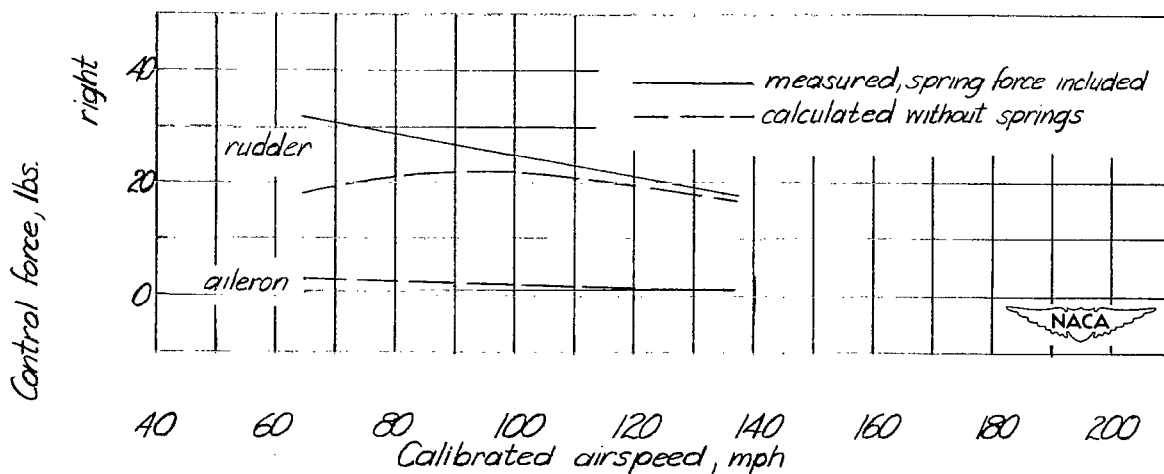
(b) Power on, clean, extreme asymmetric loading.

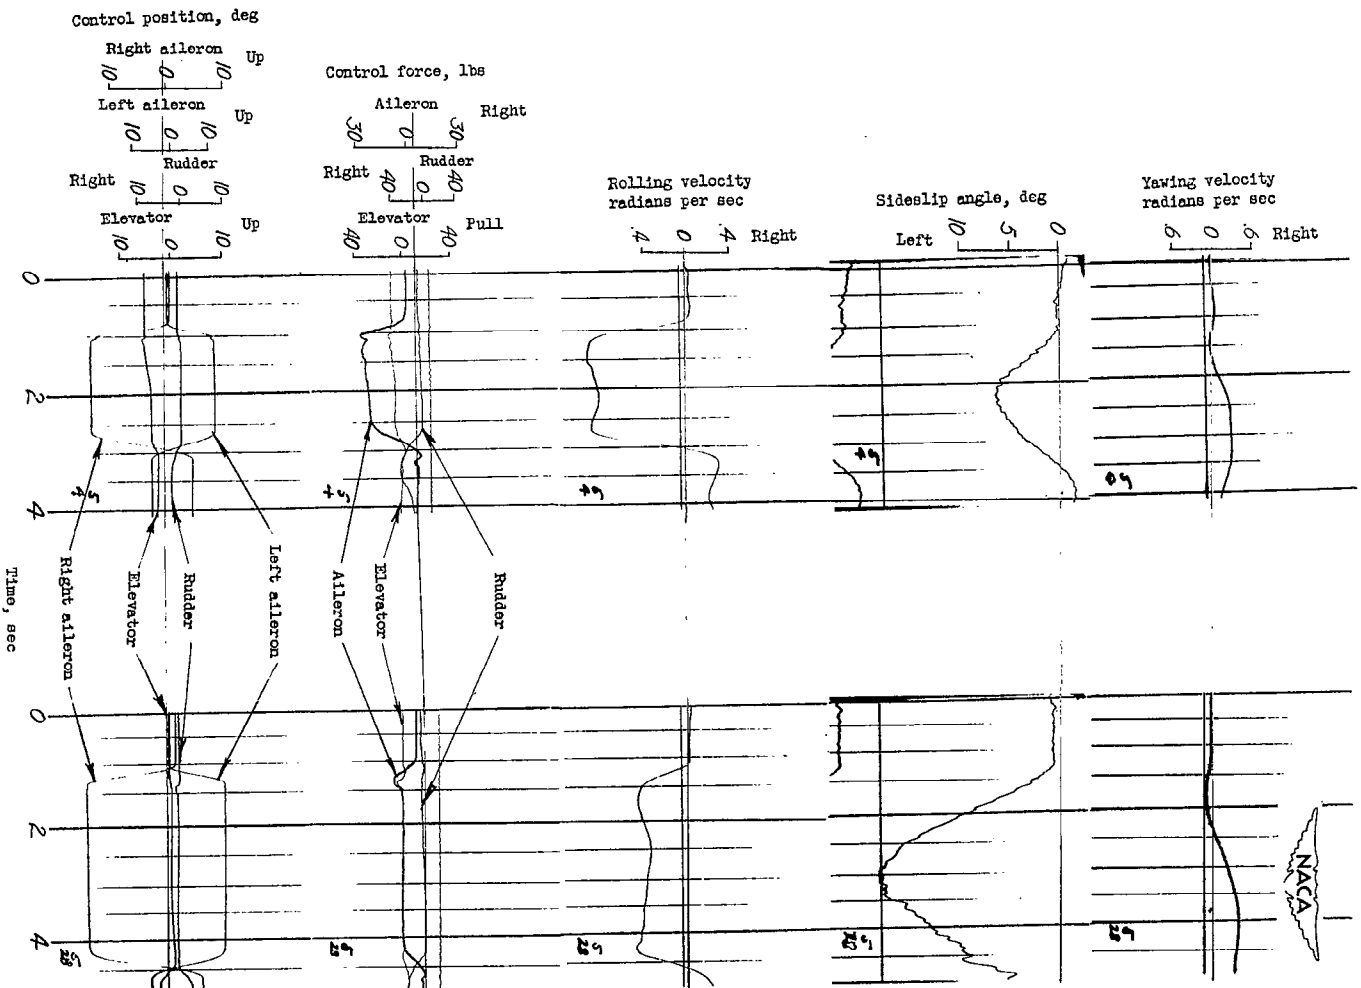
(a) 130 miles per hour; power on; (b) 67 miles per hour; power for level flight; clean.
 Figure 16.- Time histories of rudder-fixed aileron rolls in the Beech B-35 Bonanza airplane.

Aileron control characteristics.- The aileron control characteristics were measured by performing rudder-fixed aileron rolls in the clean and flaps-down conditions, both power on and power off. Time histories of typical aileron rolls are presented in figure 16. Values of the helix angle $\text{pb}/2V$, aileron force, and maximum sideslip angle plotted against total aileron deflection are shown in figure 17.

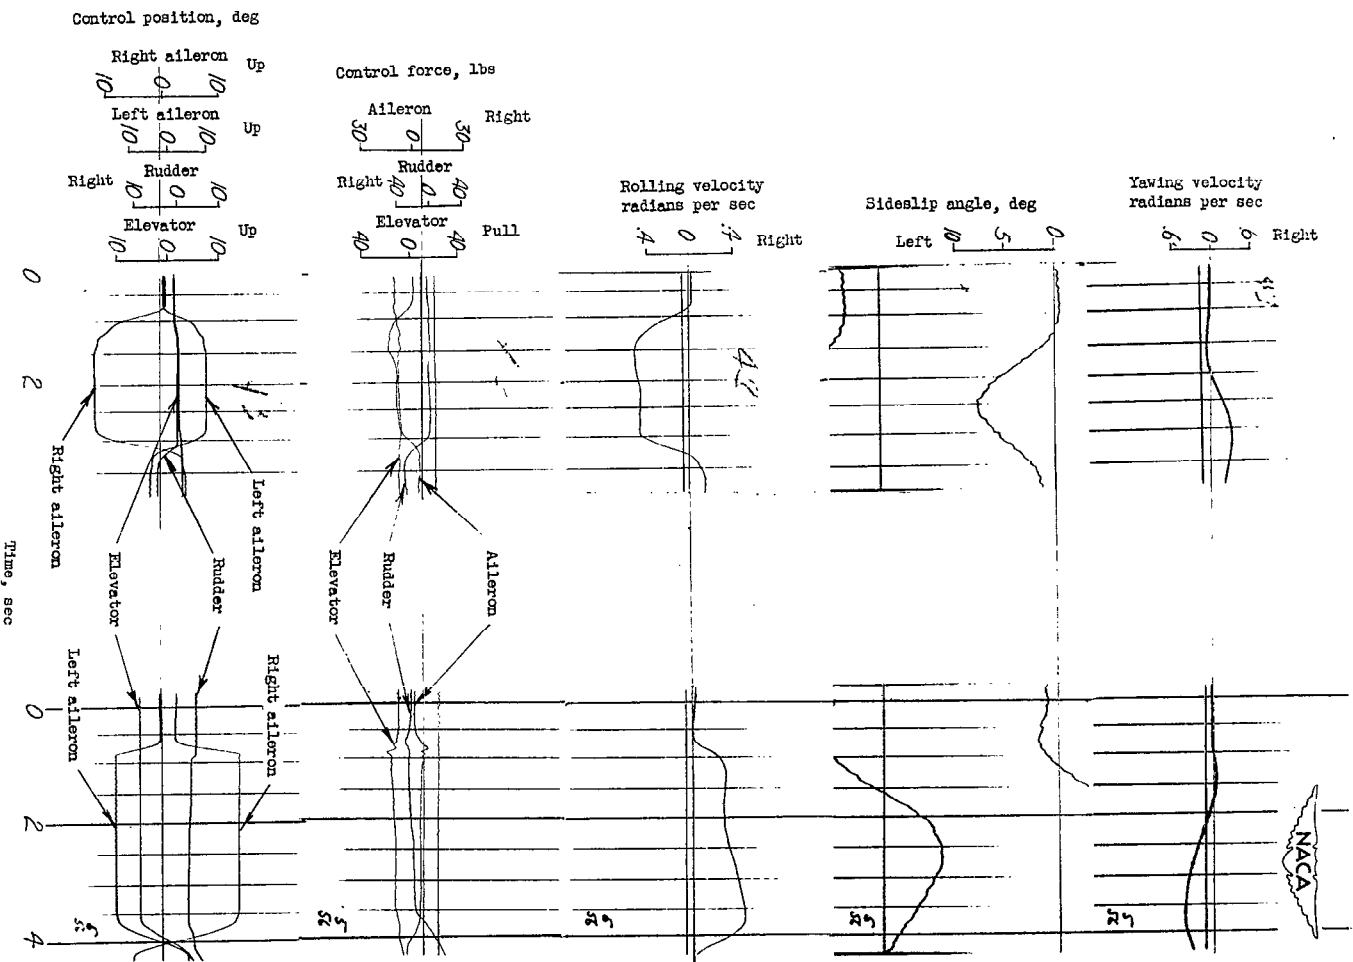
(c) 90 miles per hour; power off; flaps down. (d) 57 miles per hour; power for approach; flaps down.

Figure 16.- Concluded.

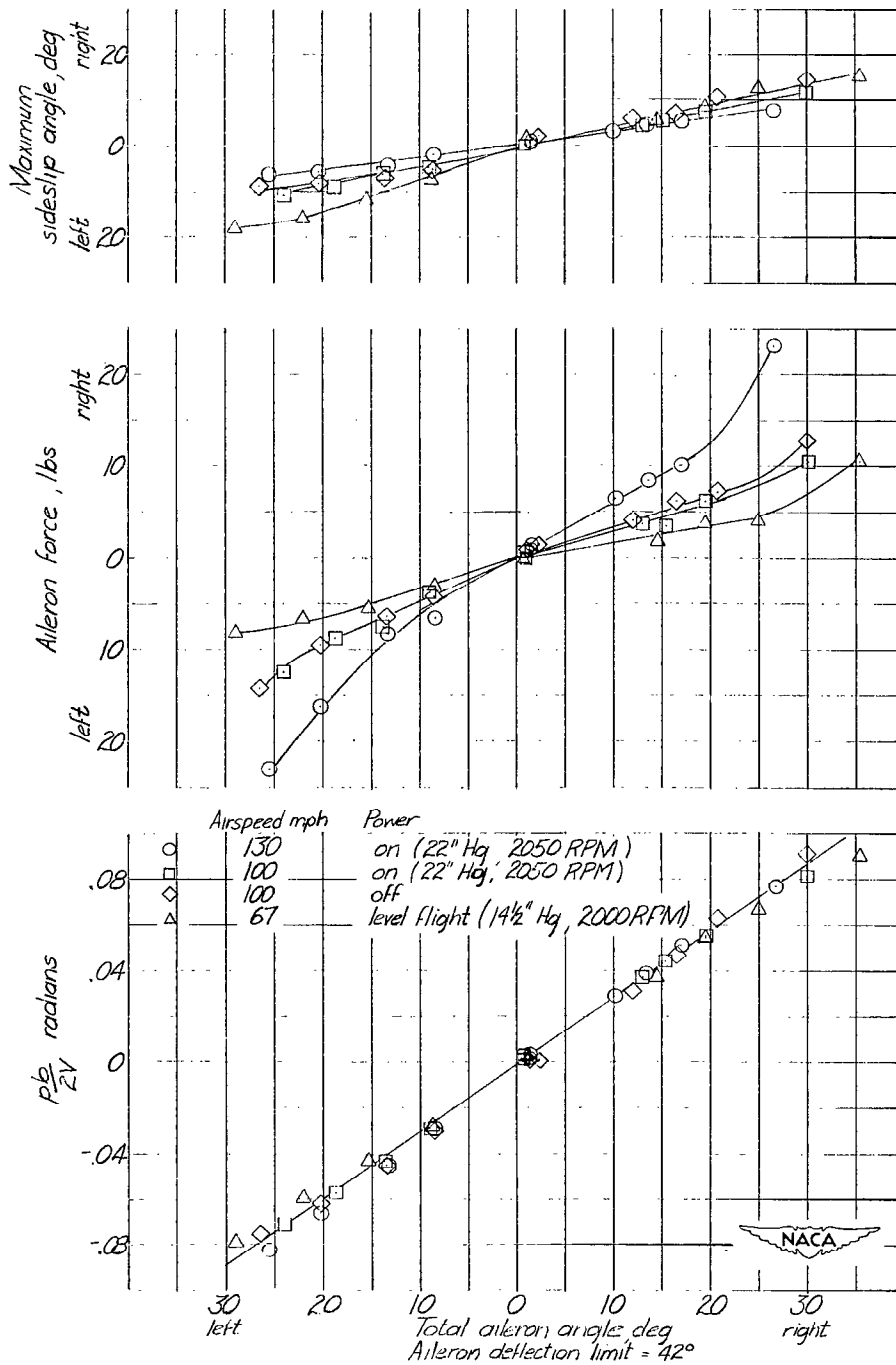
(a) Clean conditions.

Figure 17.- Variation of helix angle $\frac{pb}{2V}$; aileron force, and maximum sideslip angle with aileron angle for the rudder-fixed aileron rolls in the Beech B-35 Bonanza airplane.

Also shown in figure 17 is the maximum sideslip angle reached during the aileron rolls. Never does this sideslip angle exceed 20° and at cruising speed is approximately 5° . In this respect the airplane meets the requirements for yaw due to ailerons of reference 2. When the yaw due to aileron characteristics of the Bonanza are compared with the data in reference 1, it can be seen that the Bonanza is slightly better in this respect than the high-wing light airplanes tested previously. The maximum sideslip angle reached during full aileron rolls exceeded 20° for all the high-wing airplanes reported in reference 1. From this comparison it can be concluded that the Bonanza has slightly greater directional stability than all previously tested high-wing light airplanes.

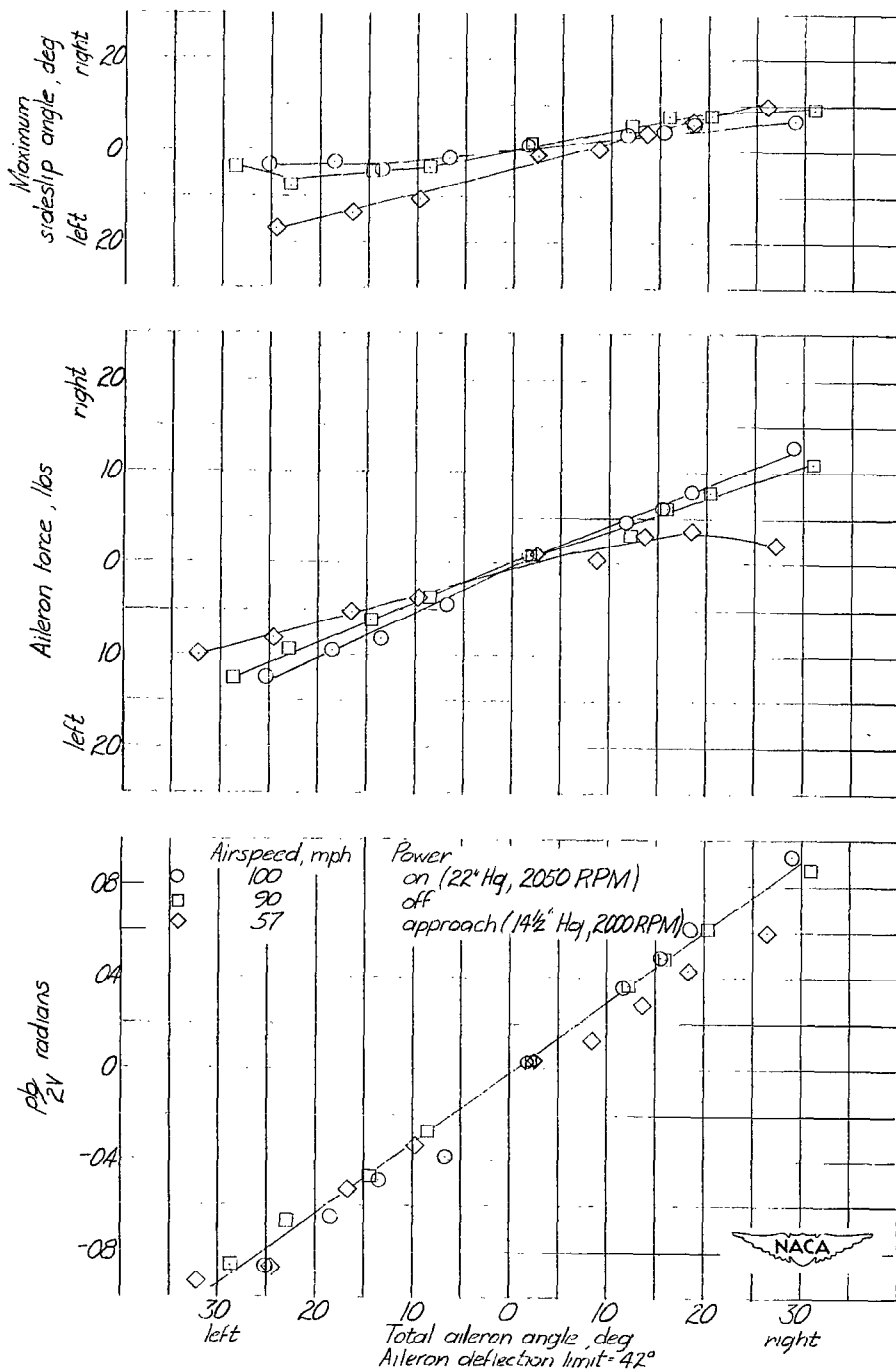
(b) Flaps-down conditions.

Figure 17.- Concluded.

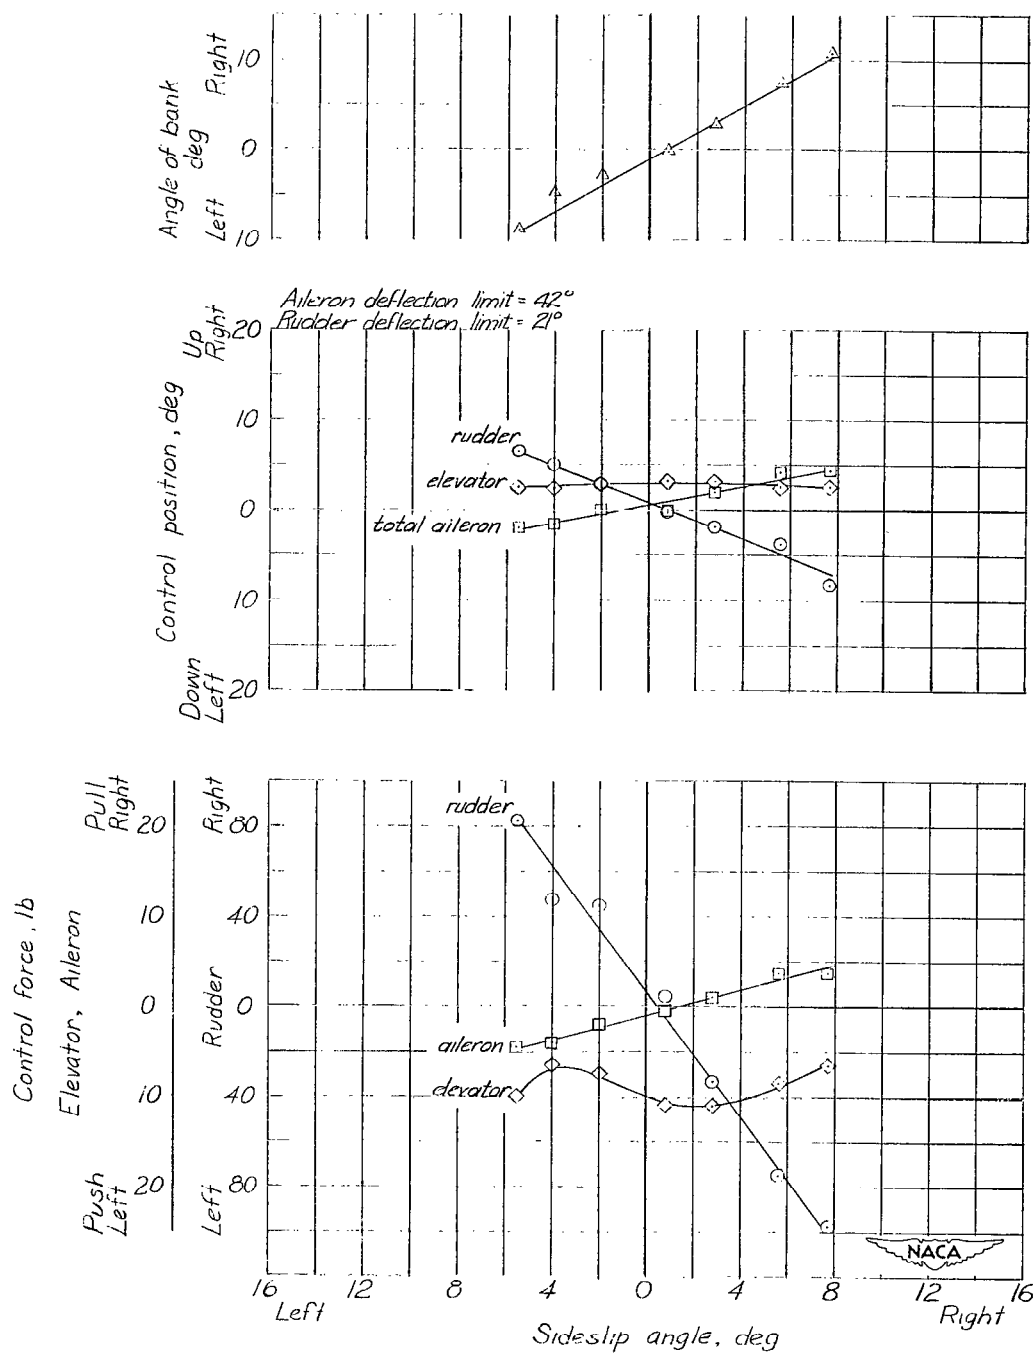
(a) Power on (22 in. Hg at 2050 rpm); clean condition;
airspeed = 160 miles per hour.

Figure 18.- Sideslip characteristics of the Beech B-35 Bonanza airplane.

Sideslip characteristics.- Results of tests of the sideslip characteristics of the Bonanza airplane are shown in figure 18. It can be seen from this figure that positive dihedral effect exists in the clean condition; that is, aileron control to depress the leading wing is required (figs. 18(a) and 18(b)). The dihedral effect is reduced in the power-off, flaps-down condition (fig. 18(c)). In the flaps-down, power-on condition, at 77 miles per hour the aileron-position variation indicates a slight negative dihedral effect, and the aileron-force variation, which includes the rudder-aileron coordinating spring force, indicates a positive stick-free dihedral effect (figure 18(d)). When the calculated spring force is subtracted from the measured aileron force, the force variation also indicates a negative dihedral effect. The spring serves the purpose of furnishing a slight stick-free positive

The variation of elevator control with sideslip angle in figure 18 indicates a satisfactorily small pitching moment due to sideslip.

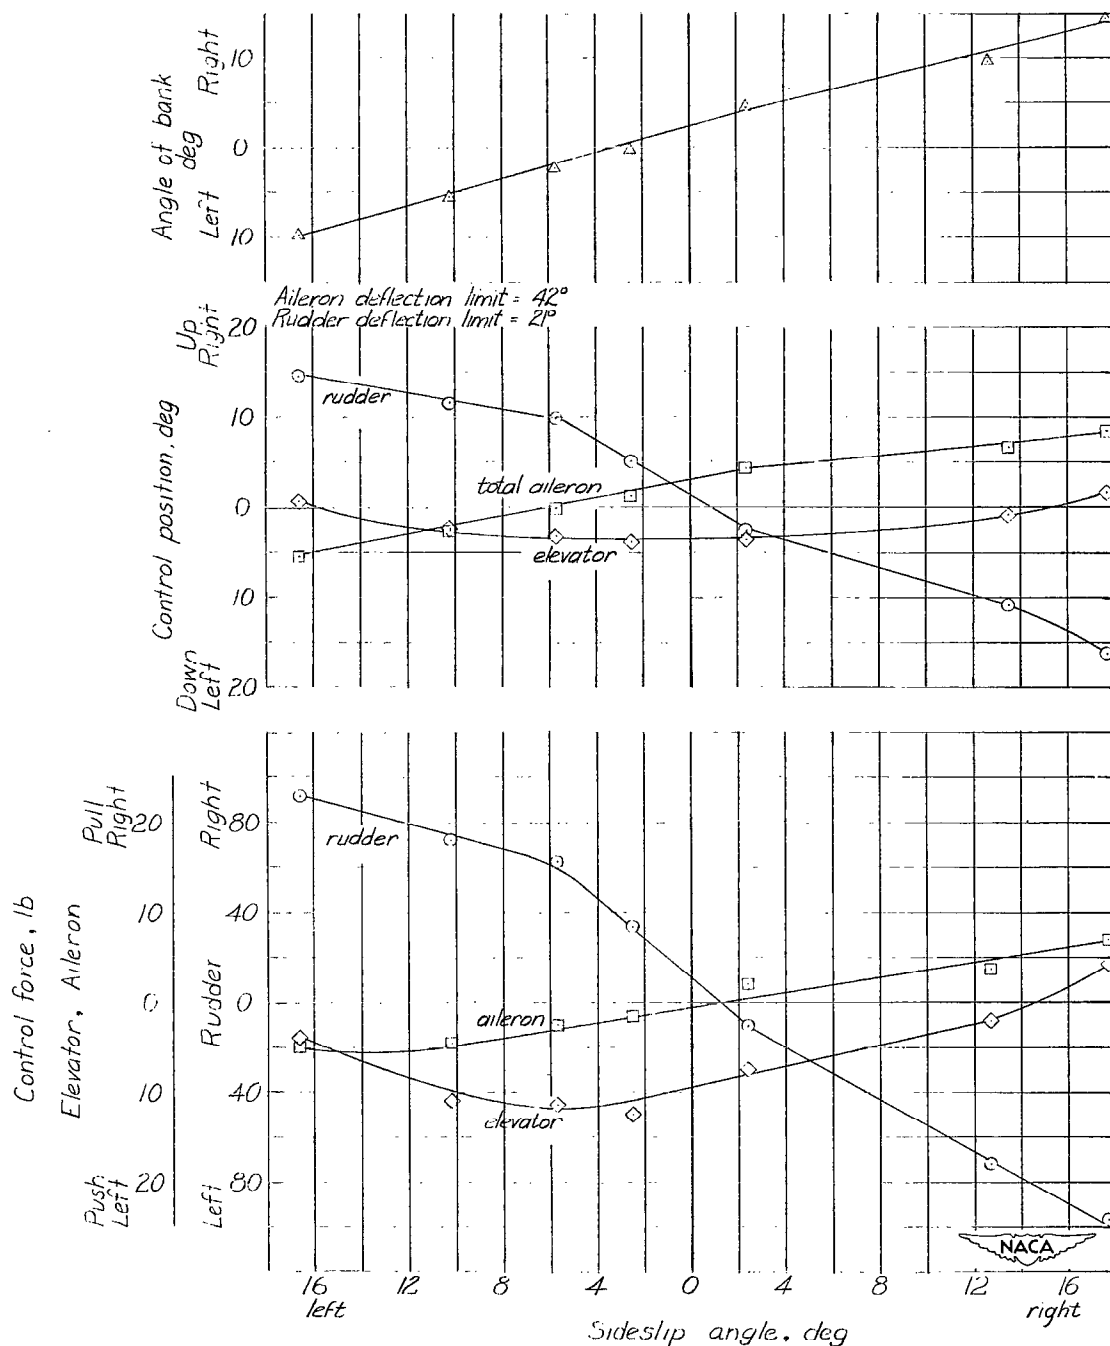
(b) Power on (22 in. Hg at 2050 rpm); clean condition;
 airspeed = 100 miles per hour.

Figure 18.- Continued.

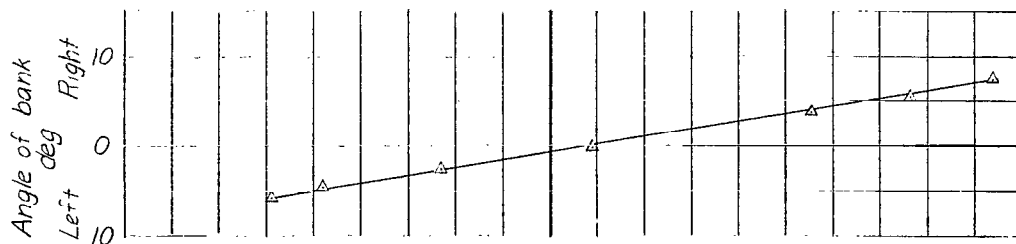
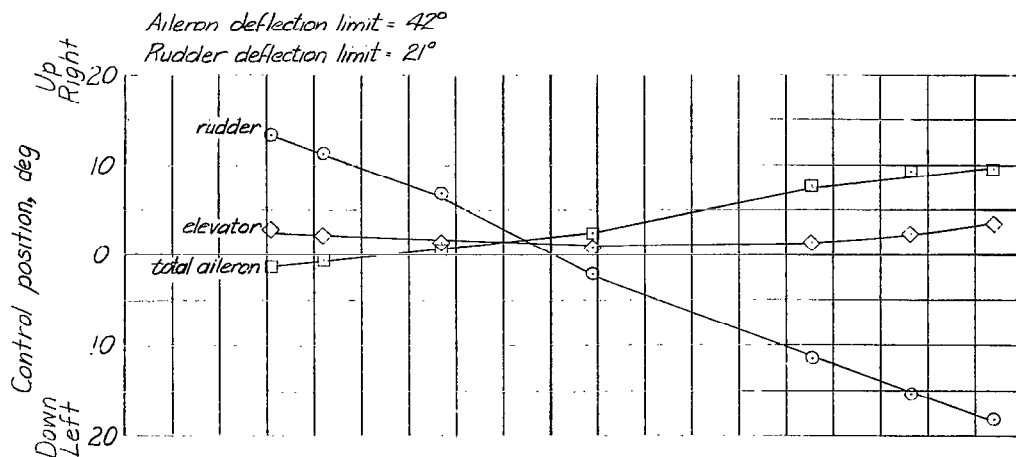
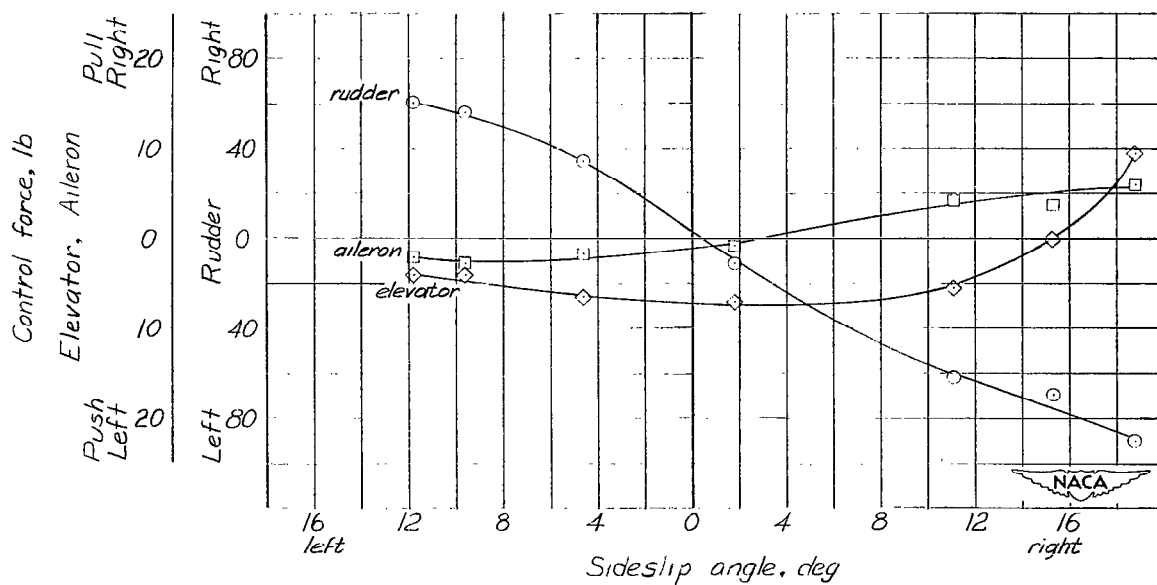
(c) Power off; flaps down; airspeed = 90 miles per hour.

Figure 18.- Continued.

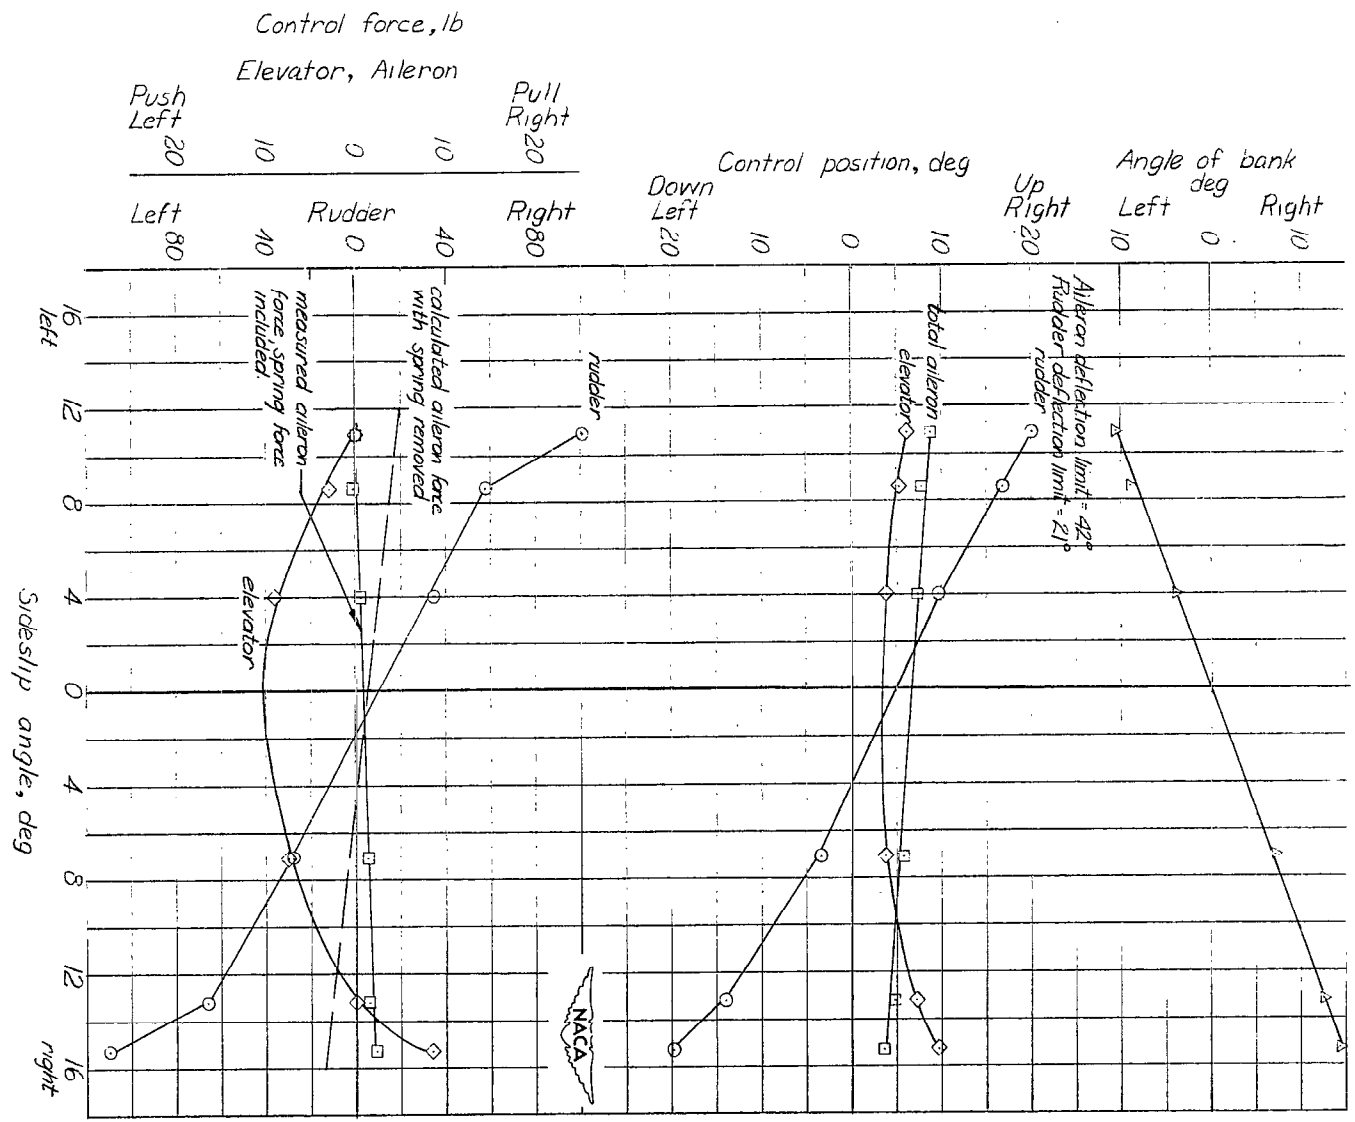
(d) Power for approach ($14\frac{1}{2}$ in. Hg at 2000 rpm); flaps down; airspeed = 77 miles per hour.

Figure 18.- Continued.

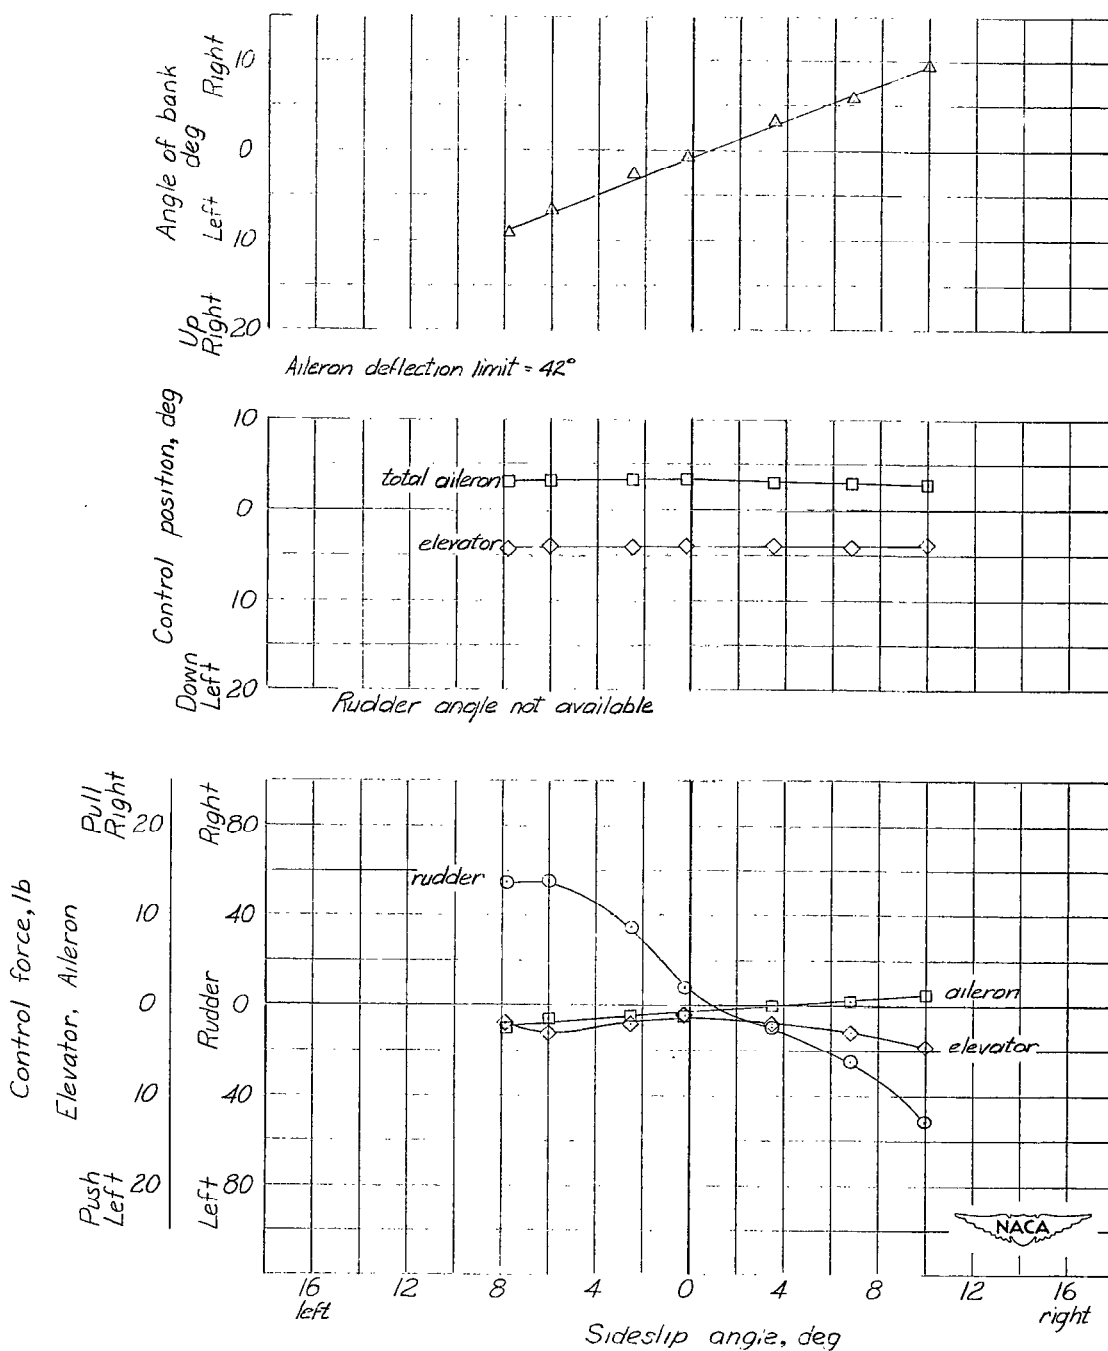
(e) Power on (22 in. Hg at 2050 rpm); flaps and gear down; airspeed = 100 miles per hour.

Figure 18.- Continued.

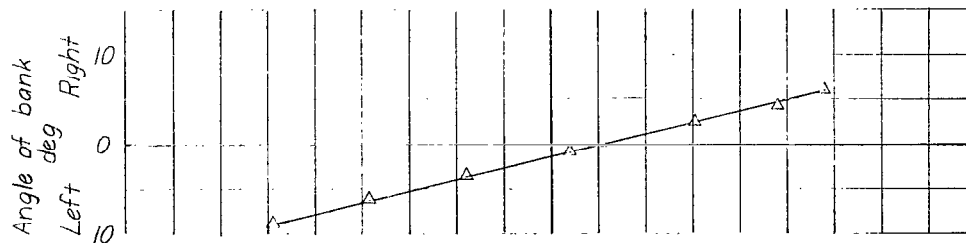
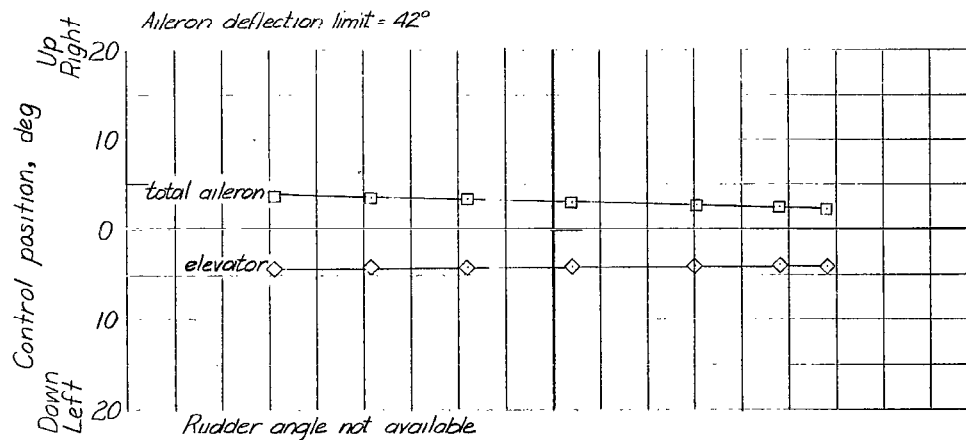
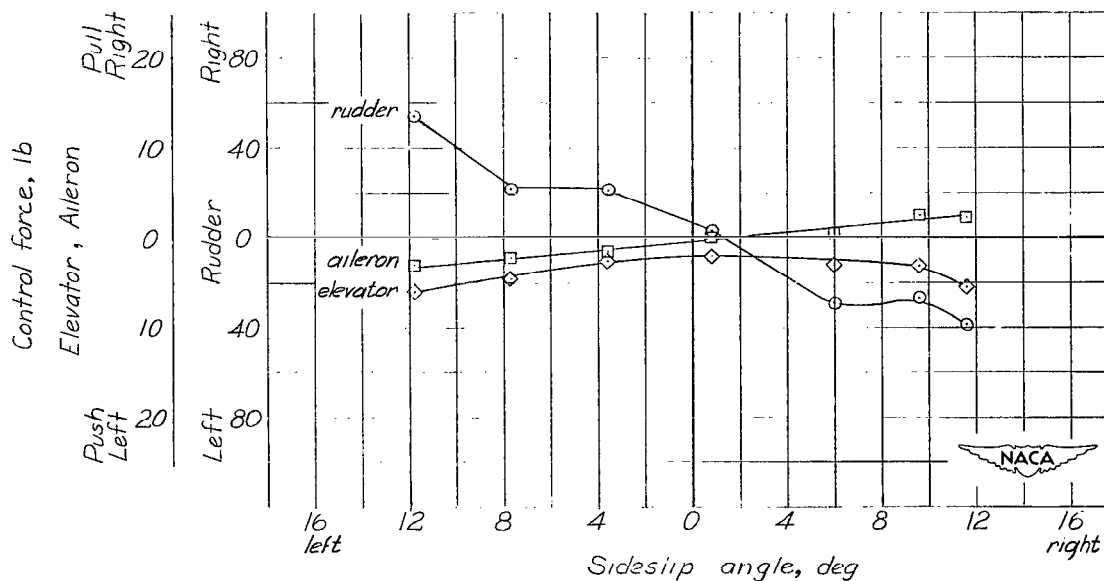
(f) Power off; flaps and gear down; airspeed = 90 miles per hour.

Figure 18.- Concluded.
